October 25, 2023

Project No. 14123-01

Subject: *Geotechnical Evaluation and Slope Stabilization Recommendations, 20 Old Ranch Road, Laguna Niguel, California*

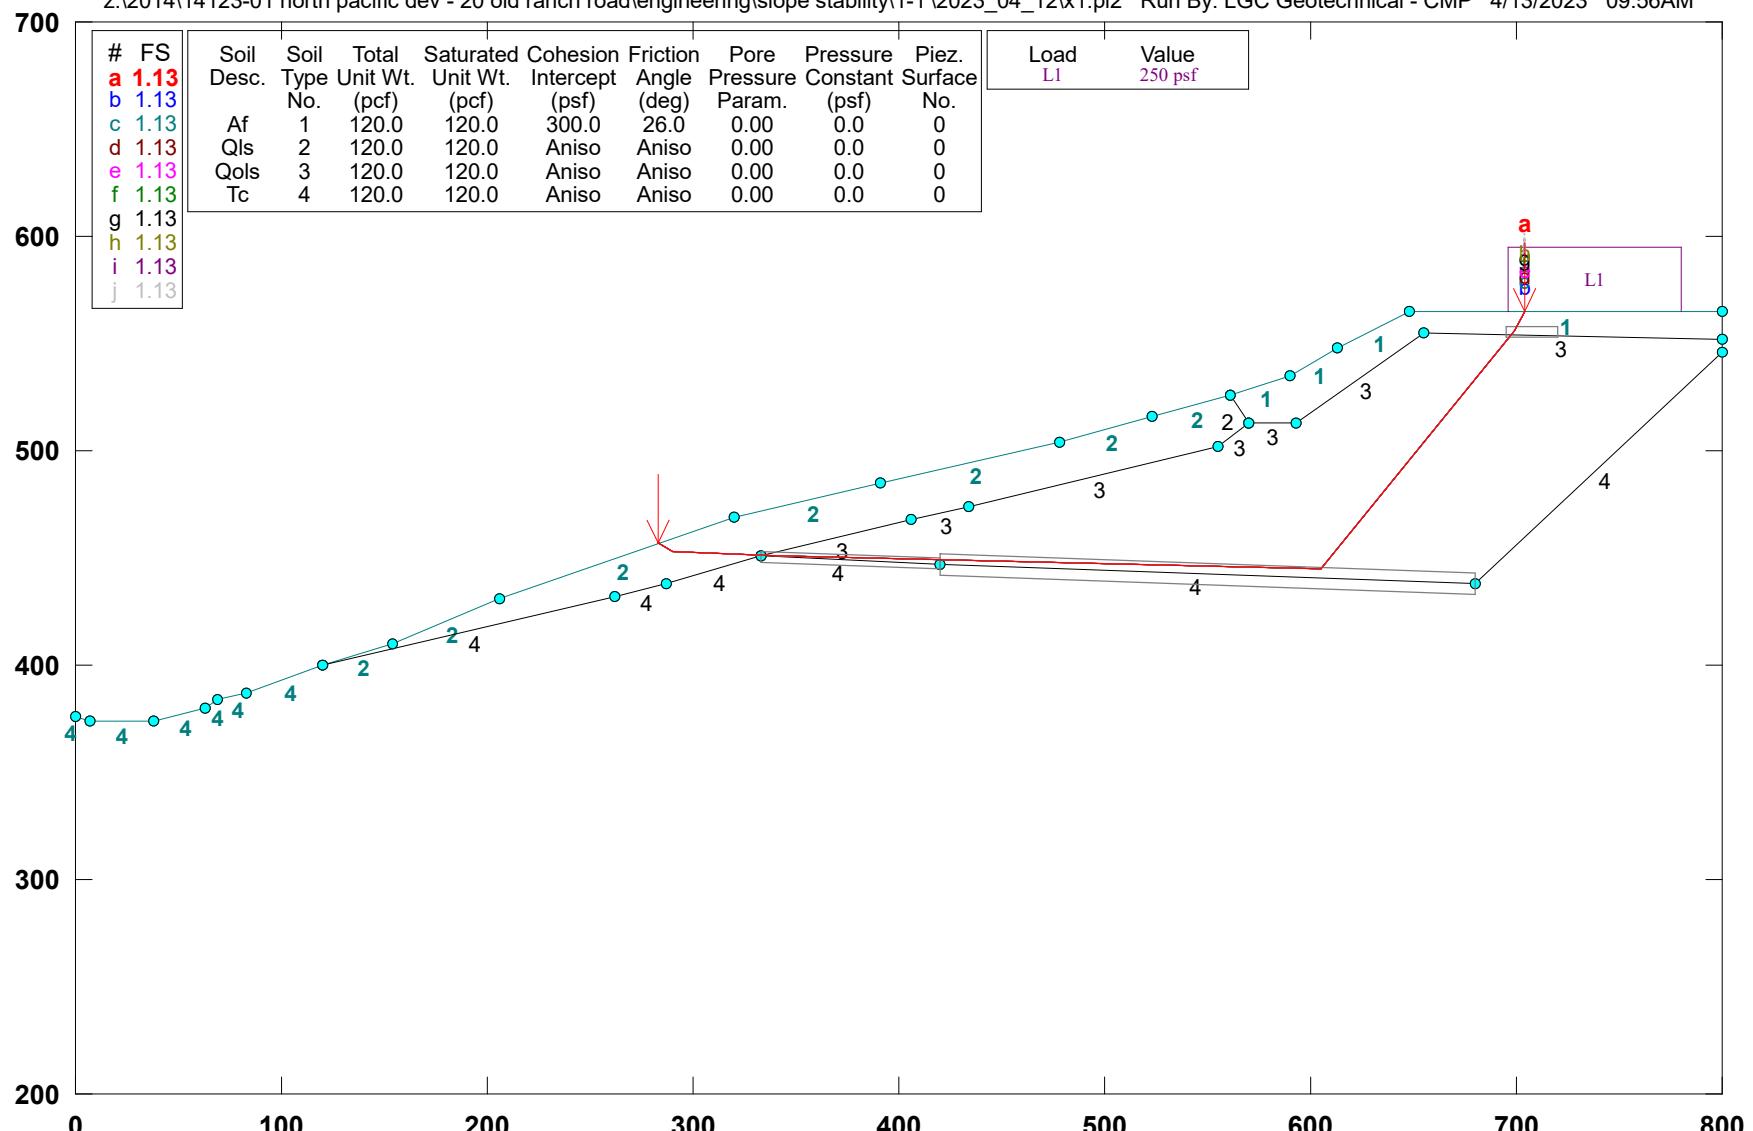
14123-01 / 20 Old Ranch Rd / 1-1' / Existing / Lower Clay (Bldg) / Static

Based on the reinterpretation of the site geologic conditions as comprised of a landslide complex rather than Capistrano Formation bedrock and in particular, the "clay bed" beneath the site as a landslide rupture surface, the site currently has a factor of safety of as low as 1.10 for global slope stability. Combined with the proposed grading, partial removal and buttressing

GSTABL7 v.2 FSmin=1.13

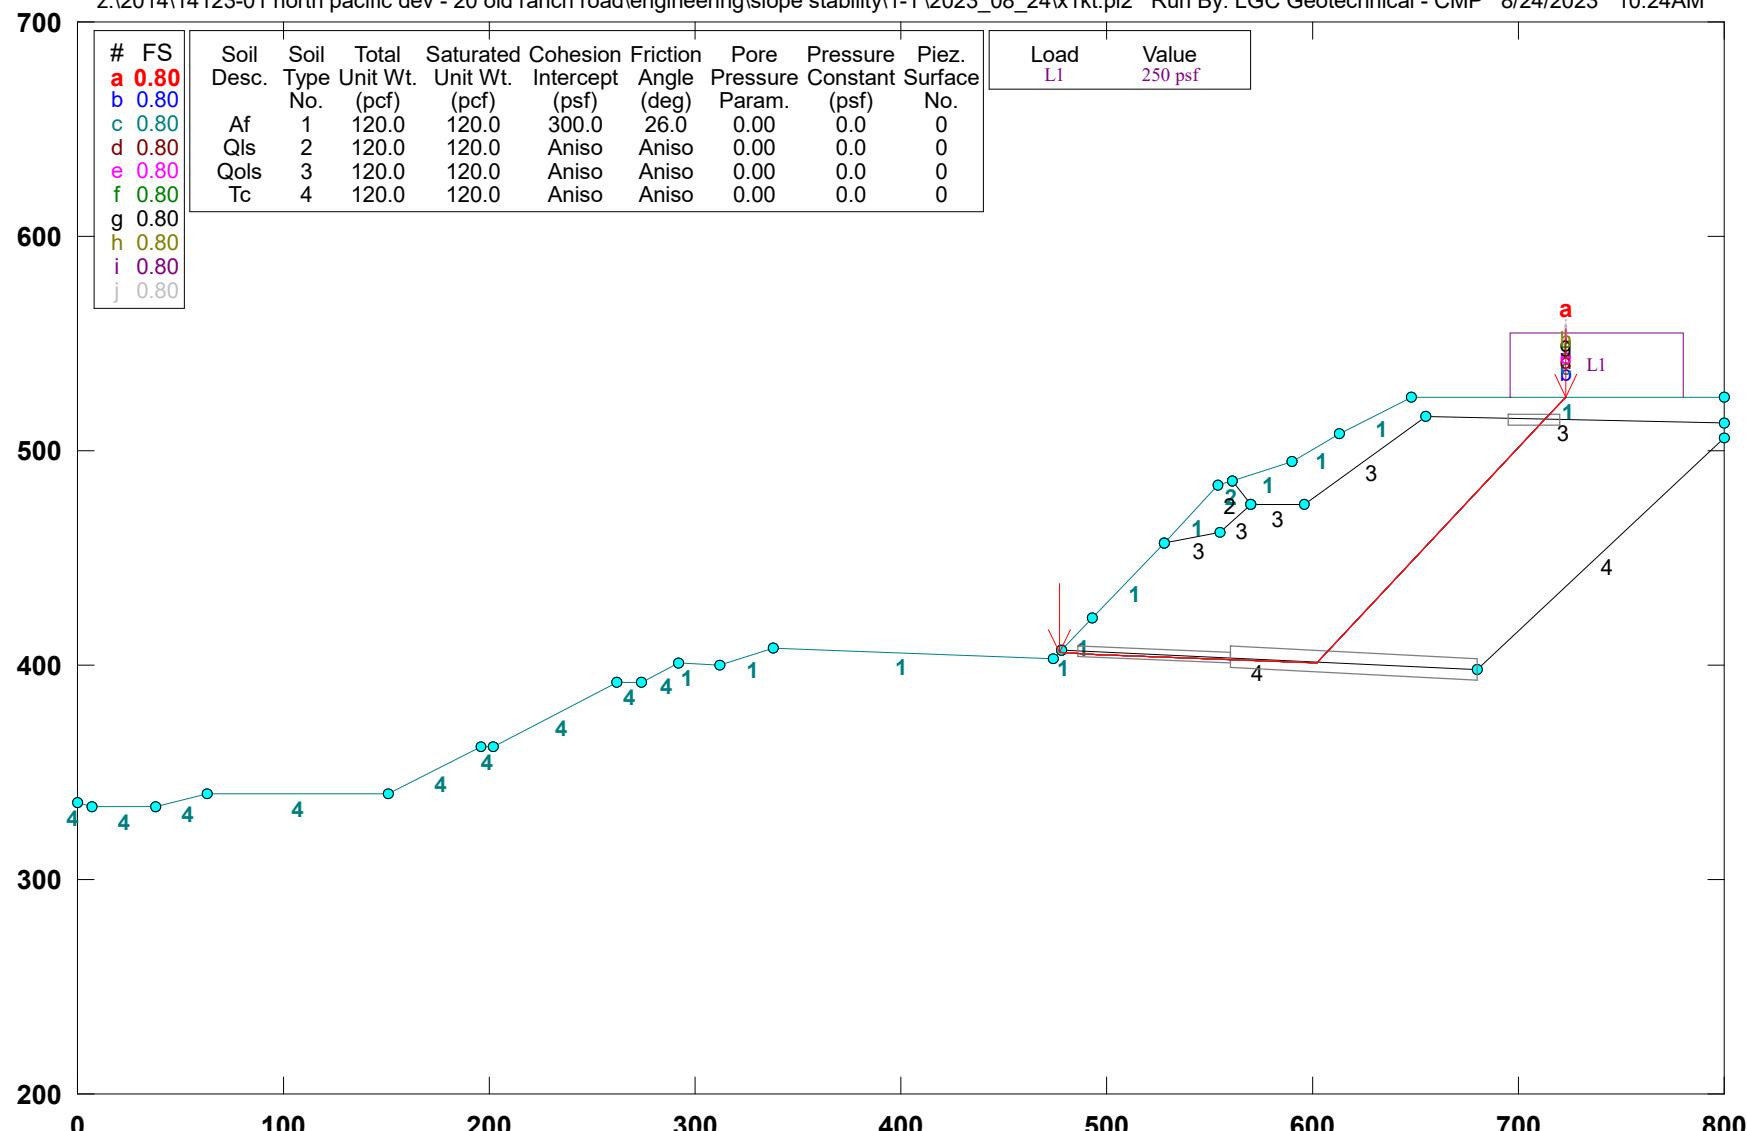
14123-01 / 20 Old Ranch Rd / 1-1' / Temporary / Keyway / Static

The analysis for the temporary condition of Geotechnical Cross Sections 1-1' and 2-2' have a factor of safety less than 1.25, at 0.80 and 0.84, respectively. This indicates a backcut failure could occur within the left-in-place landslide material if the entire keyway is opened up at once. To help prevent this from happening, the keyway should be excavated in 20-foot width slot cuts. Analysis of the temporary condition with 20-foot slot cuts for Geotechnical Cross Section 1-1' and 2-2' is included in Appendix E showing a factor of safety of 3.31 and 3.14, respectively.

GSTABL7 v.2 FSmin=0.80

In order to expedite improvement of the stability of the site, it may be necessary to construct the recommended buttress and restore site grades to the current topography as an "interim grade" until the proposed grading plans are revised, submitted and approved by the City. Based on our analysis, construction of the recommended buttress and restoring the site to the current site topography will achieve a global factor of safety of approximately 1.24. Ultimately, the proposed design grading and modification thereto, provided herein, will need to be performed to achieve slope stability factor of safety of 1.5 for the site.

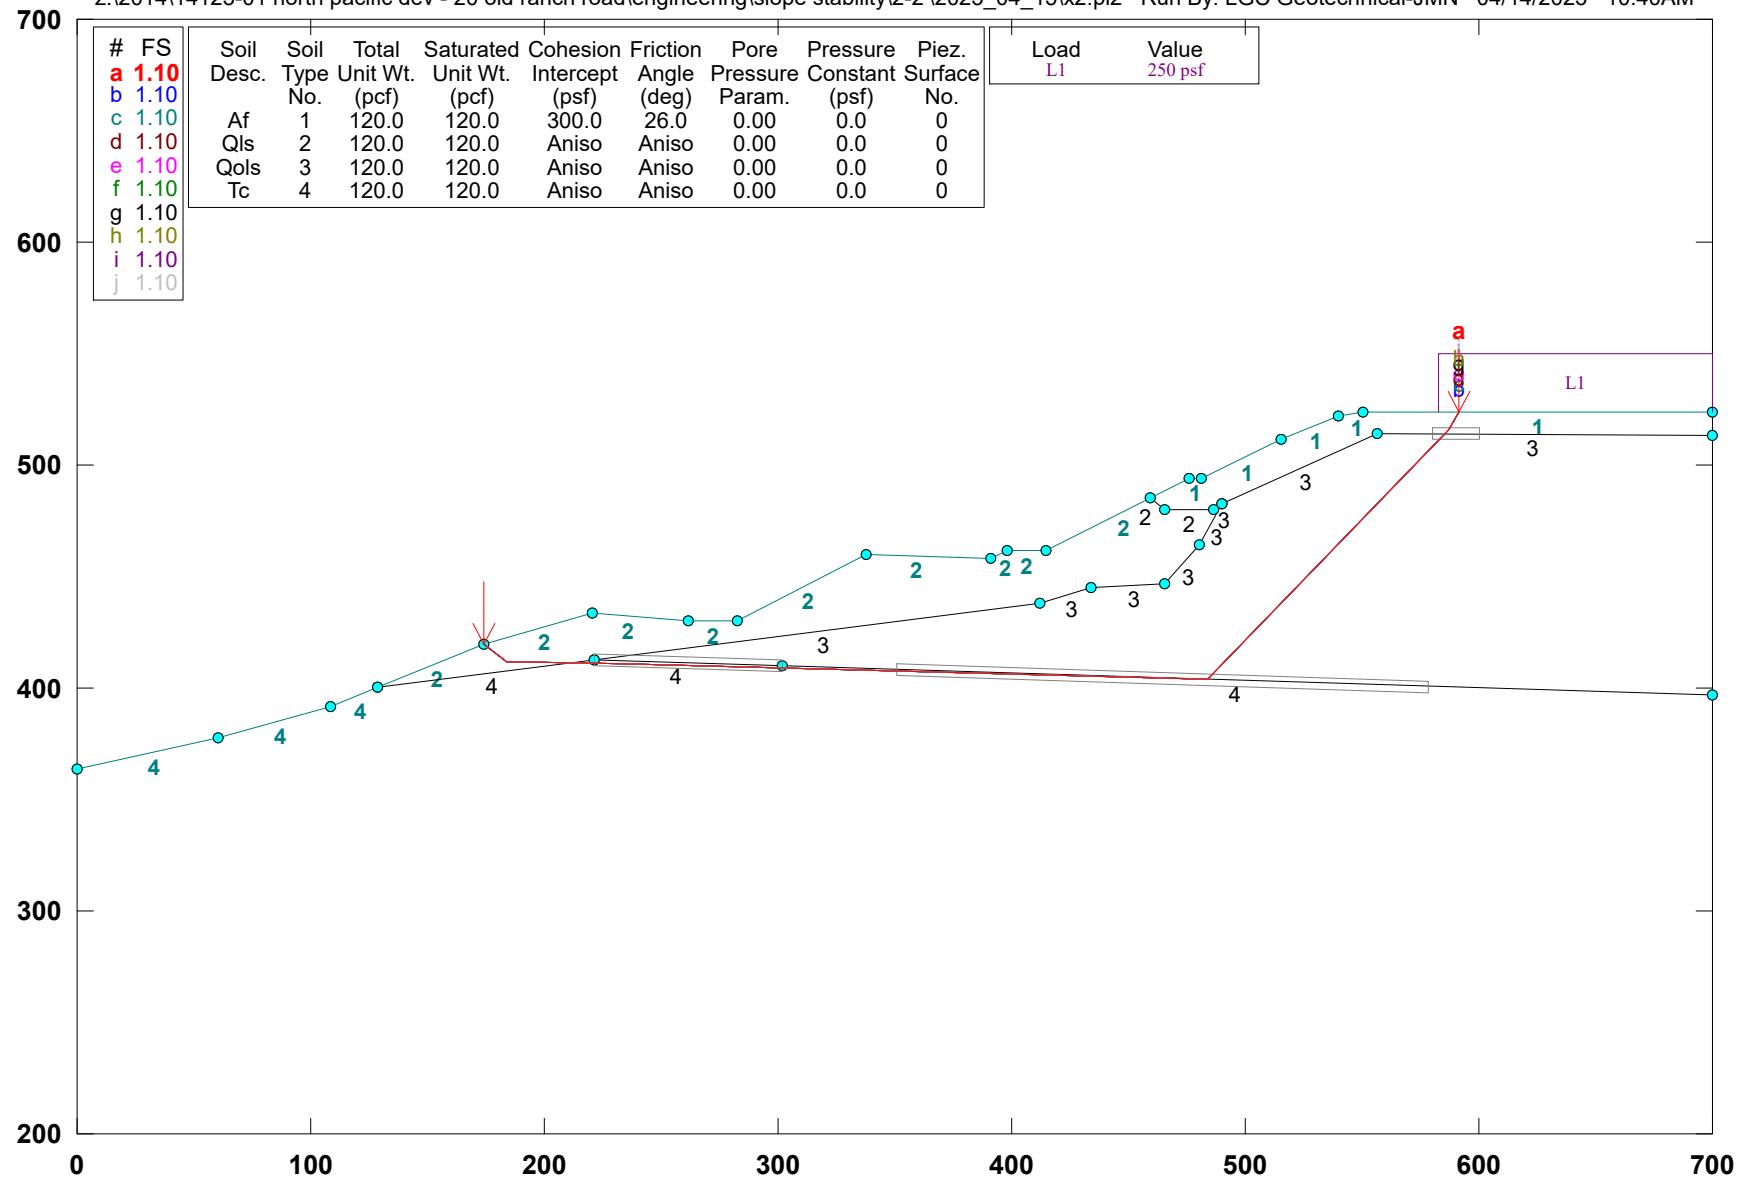
14123-01 / 20 Old Ranch Rd / 2-2' / Existing / Lower Clay (Bldg) / Static

GSTABL7 v.2 FSmin=1.10

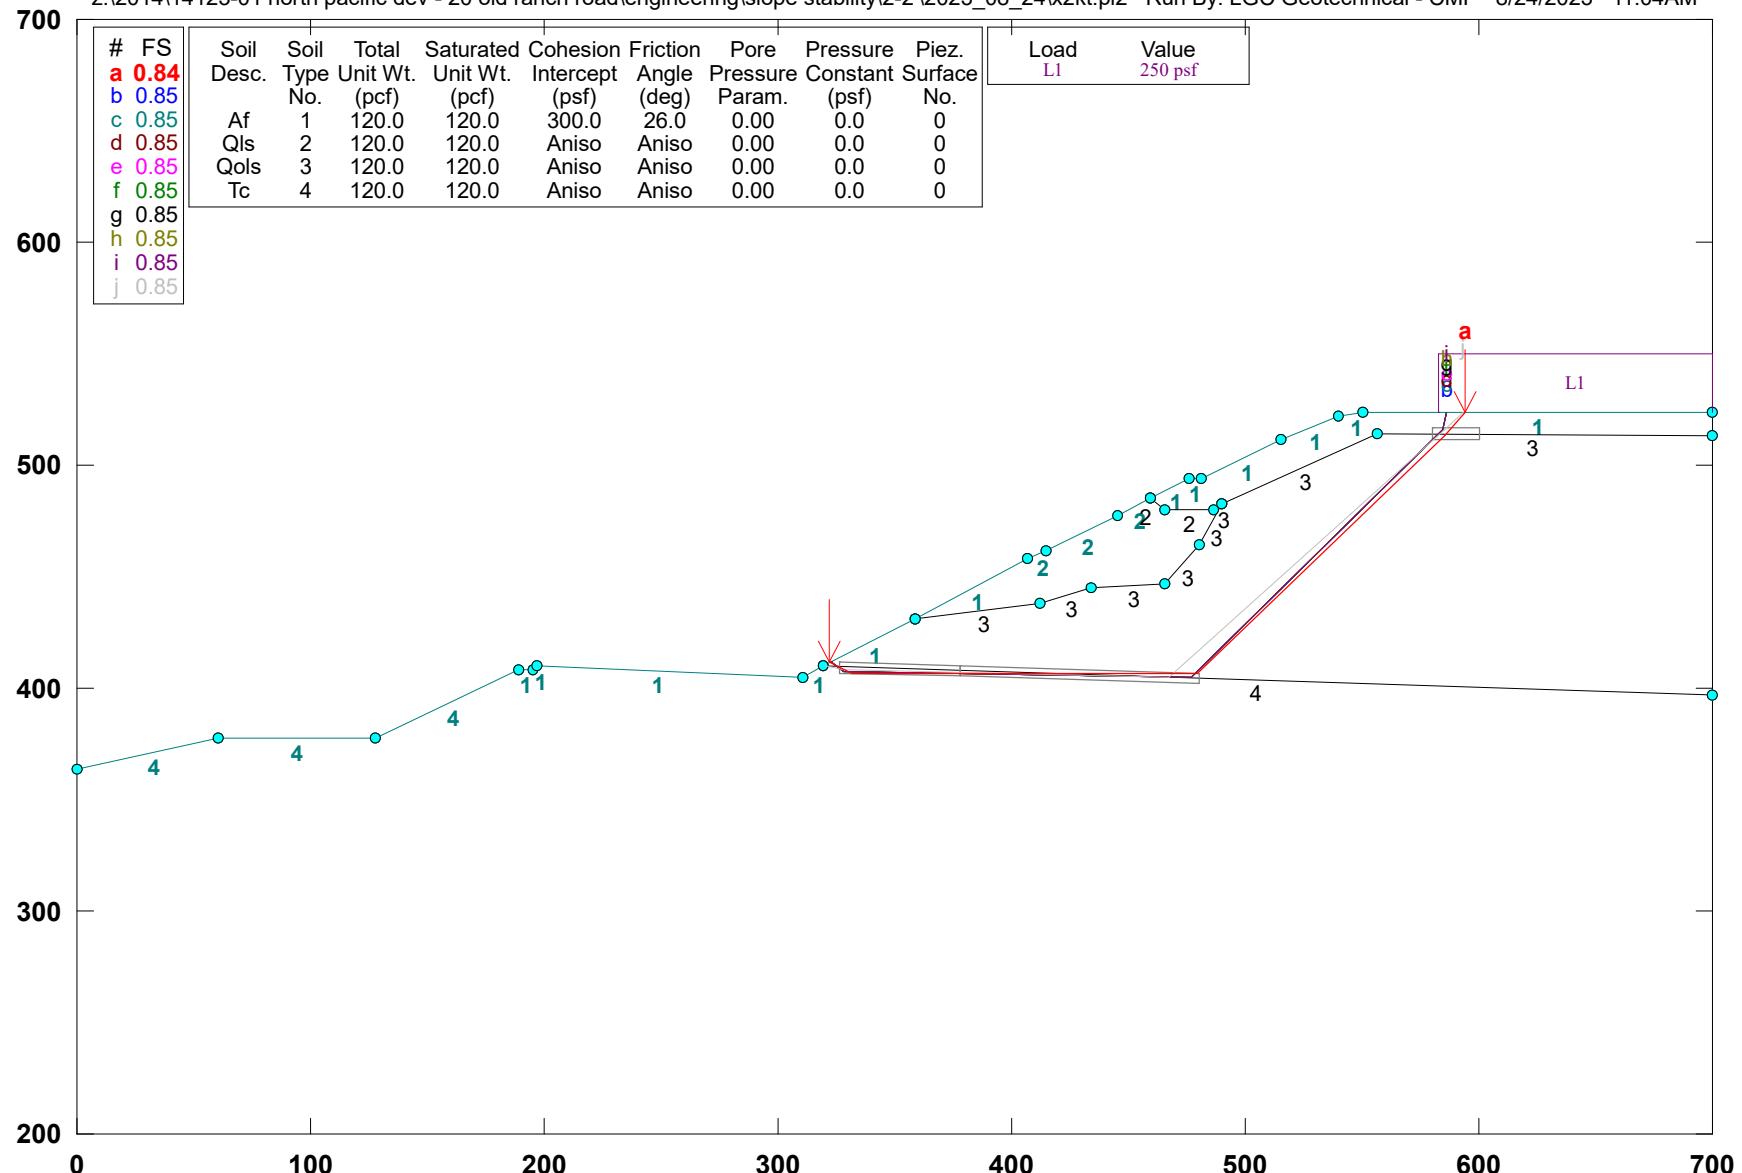
14123-01 / 20 Old Ranch Rd / 2-2' /Temporary / Keyway / Static

GSTABL7 v.2 FSmin=0.84
